**2014-2015 Dry Weather WQO Ratios
for S28 Dominguez Channel at Artesia Blvd.**

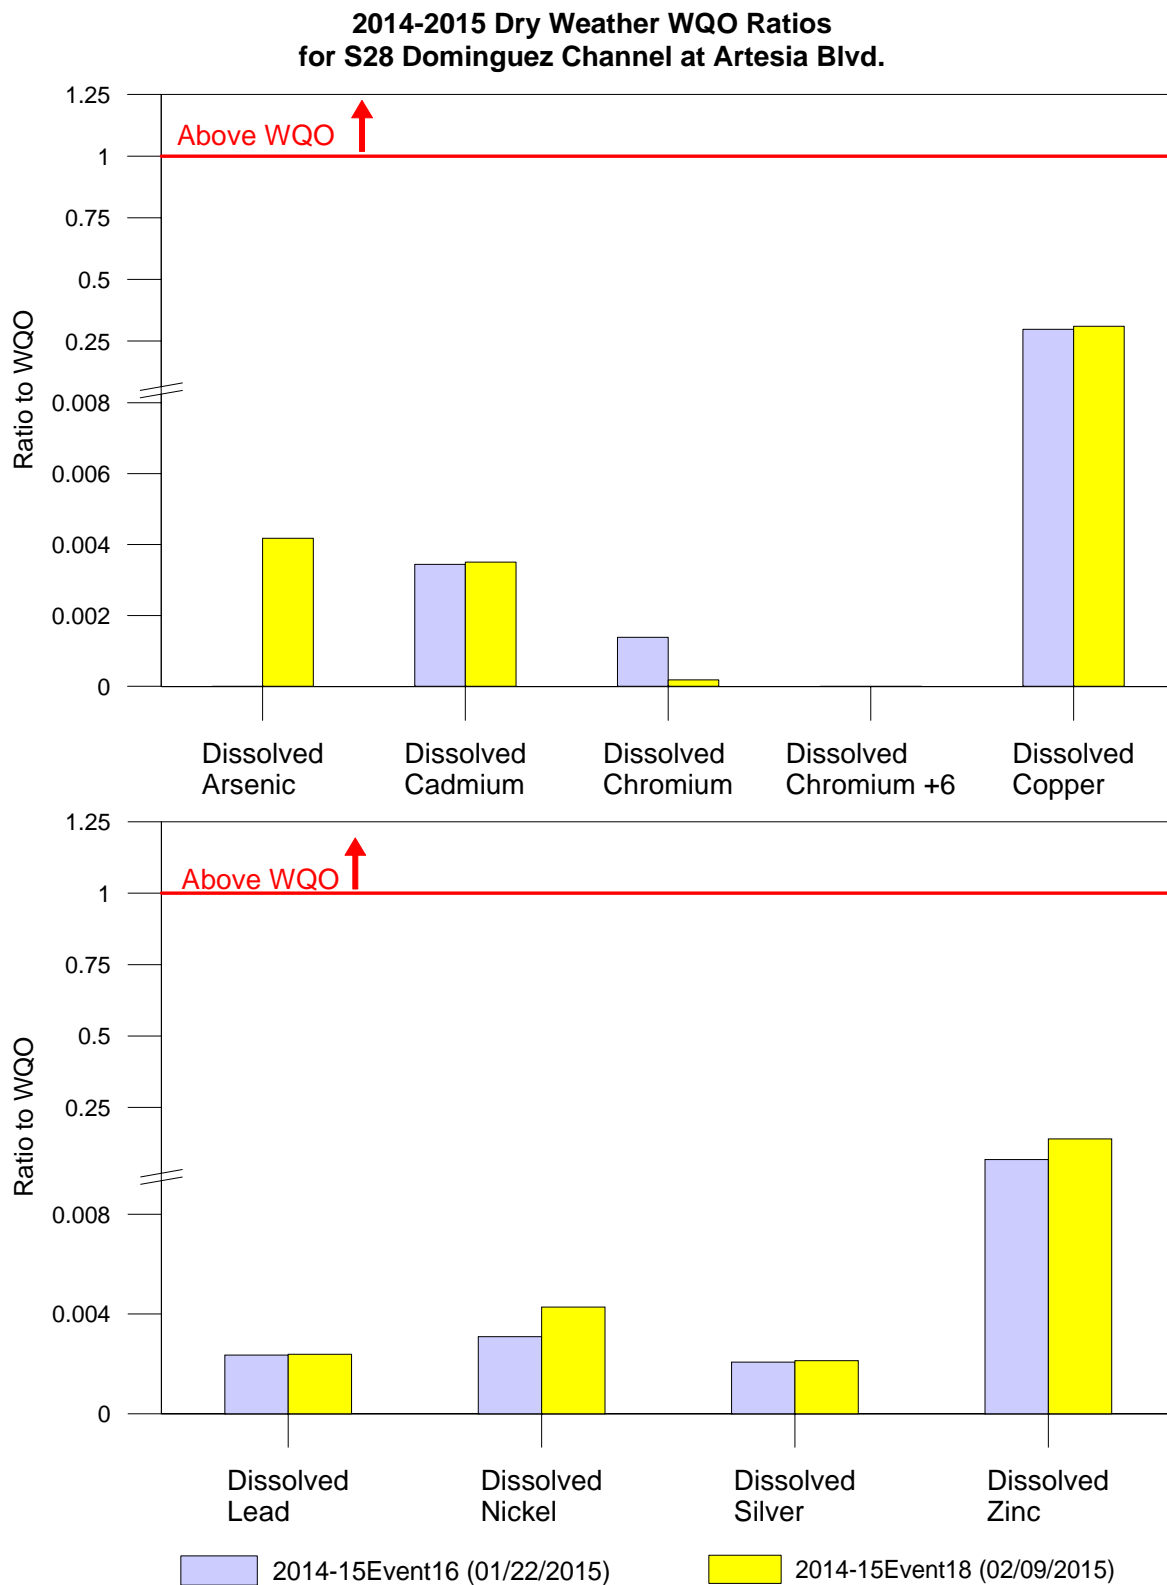
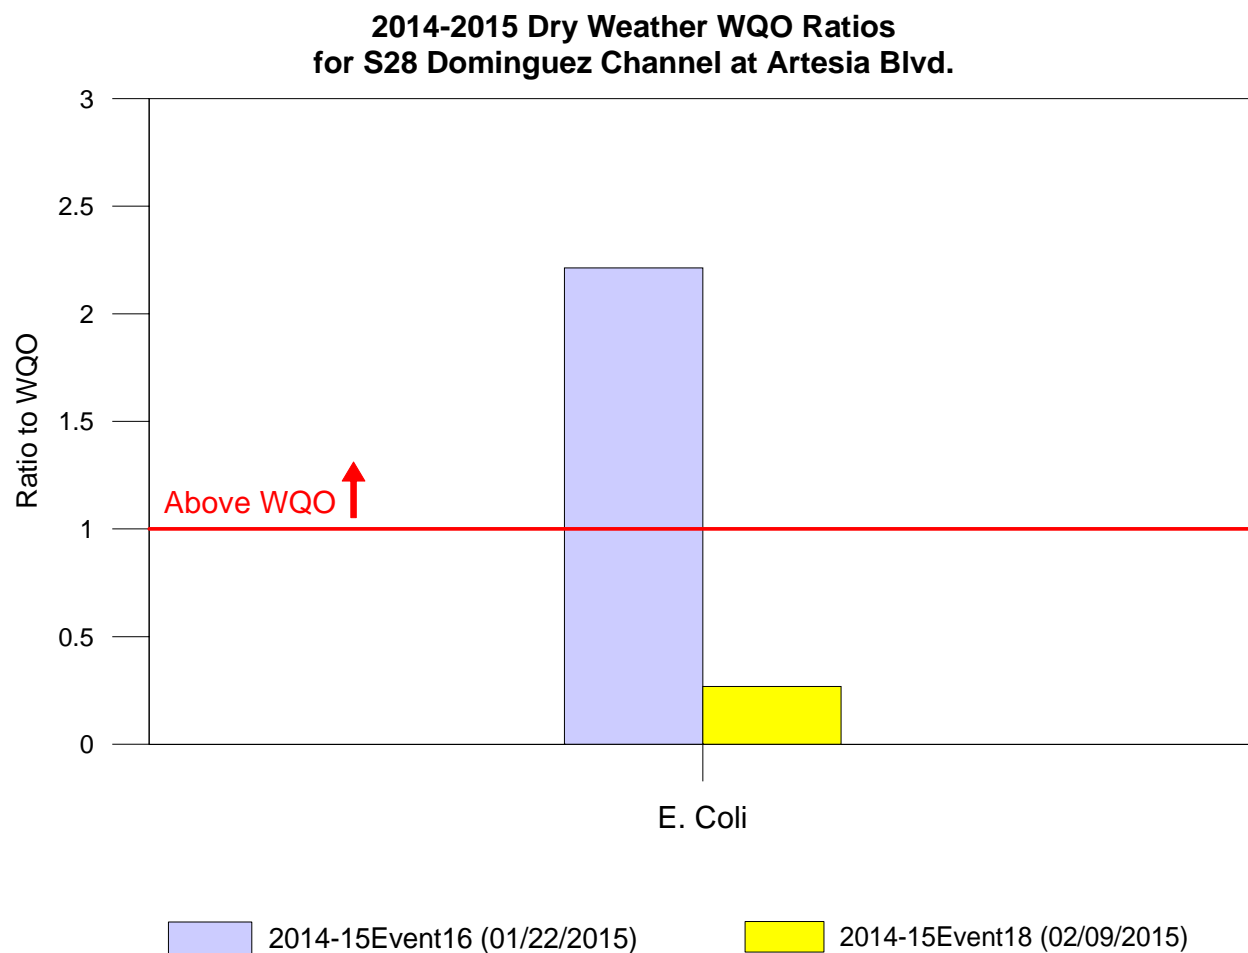
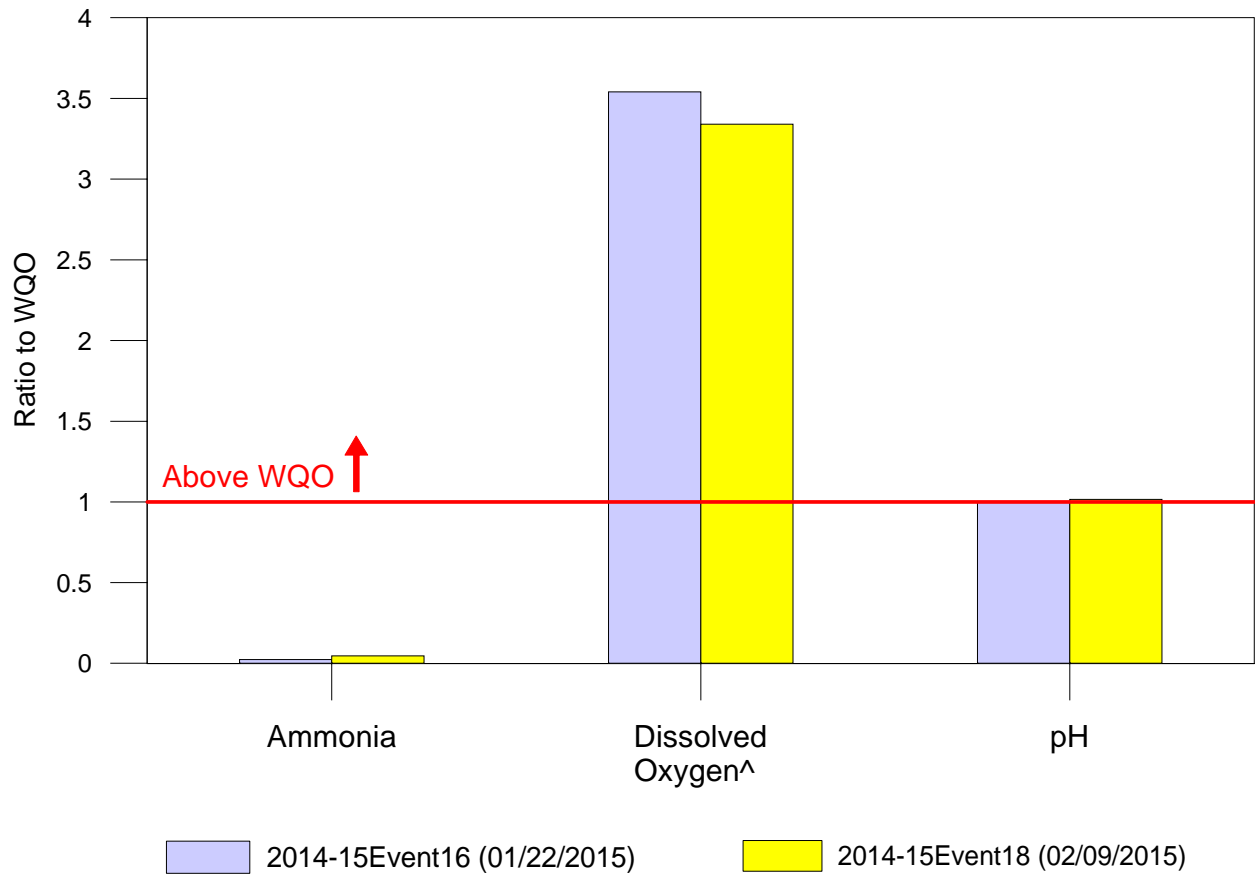
Figure 4-5.6 S28 Dominguez Channel at Artesia Blvd Dry Weather Ratio Plots

^Dissolved oxygen is an exceedance if ratio to WQO is below 1.
